Manhole Inspection Summary

Manhole # S45MM_049MH

Inspection ☐ Is Incomplete Rating: **3) Fair**

Insp Date: **3/25/08 12:24 PM**

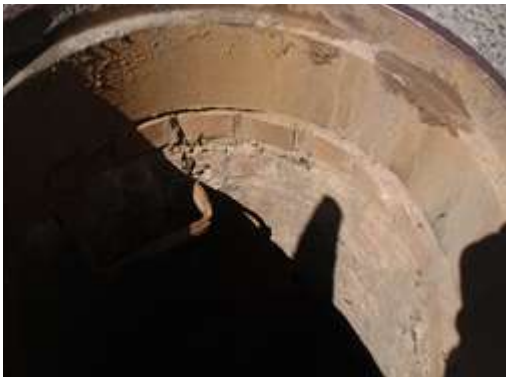
Defect 1

Condition: ☐ Sound ☐ Cracked ☐ Root Intrusion ☒ **Loose Brick** ☐ Deteriorated

Infiltration: ☐ None ☐ Joint ☐ Cracks ☒ **Mortar** ☐ Roots ☒ **Wall**

Adjustment joint

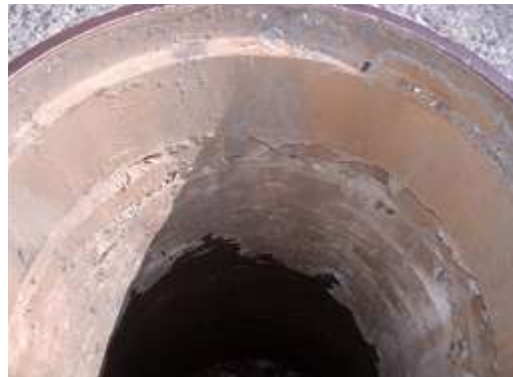
Defect 2

☒ **Leaks**

frame leaks

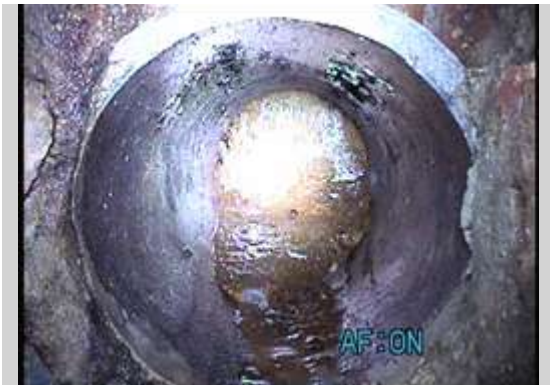
1 O'Clock Inflow

Pipe Height: **8.4** (in.) Rod and Bar (Angled)
Pipe Material: **Clay** ☐ Pipe Lined
Invert Depth: **11.90** (ft.) Flow Characteristics: **None**
Deposits: ☐ None ☐ Mud ☐ Sludge ☒ **Debris** ☐ Grease
Silt Depth: **8** (in.) Deposits Extent: **Heavy**
Infiltration: **None** Pipe Seal Cond: **Sound**

Connects To: **Stub connection / abandoned**

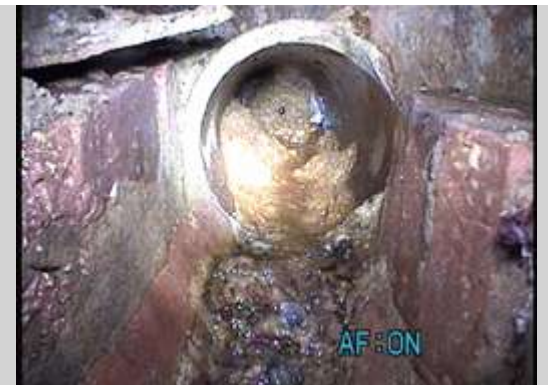
10 O'Clock Inflow

Deposits: ☐ None ☐ Mud ☐ Sludge ☒ **Debris** ☐ Grease

Silt Depth: **8** (in.) Deposits Extent: **Heavy**

Connects To: **Stub connection / abandoned**
